MUNICIPAL LANDFILL AUDIT REPORT

2021

LAMBERT DE KLERK

Manager: Environmental Affairs

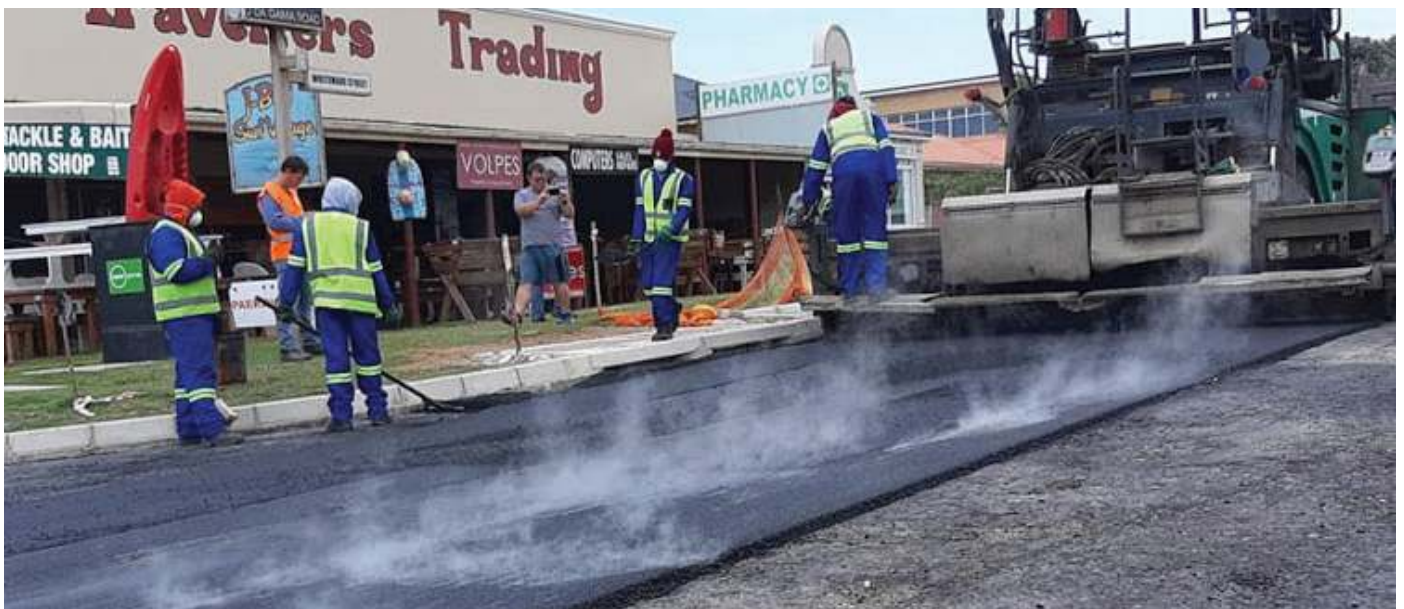
A street in Jeffreys Bay is repaired by making use of plastic waste
