MUNICIPAL LANDFILL AUDIT REPORT

2021

LAMBERT DE KLERK

Manager: Environmental Affairs

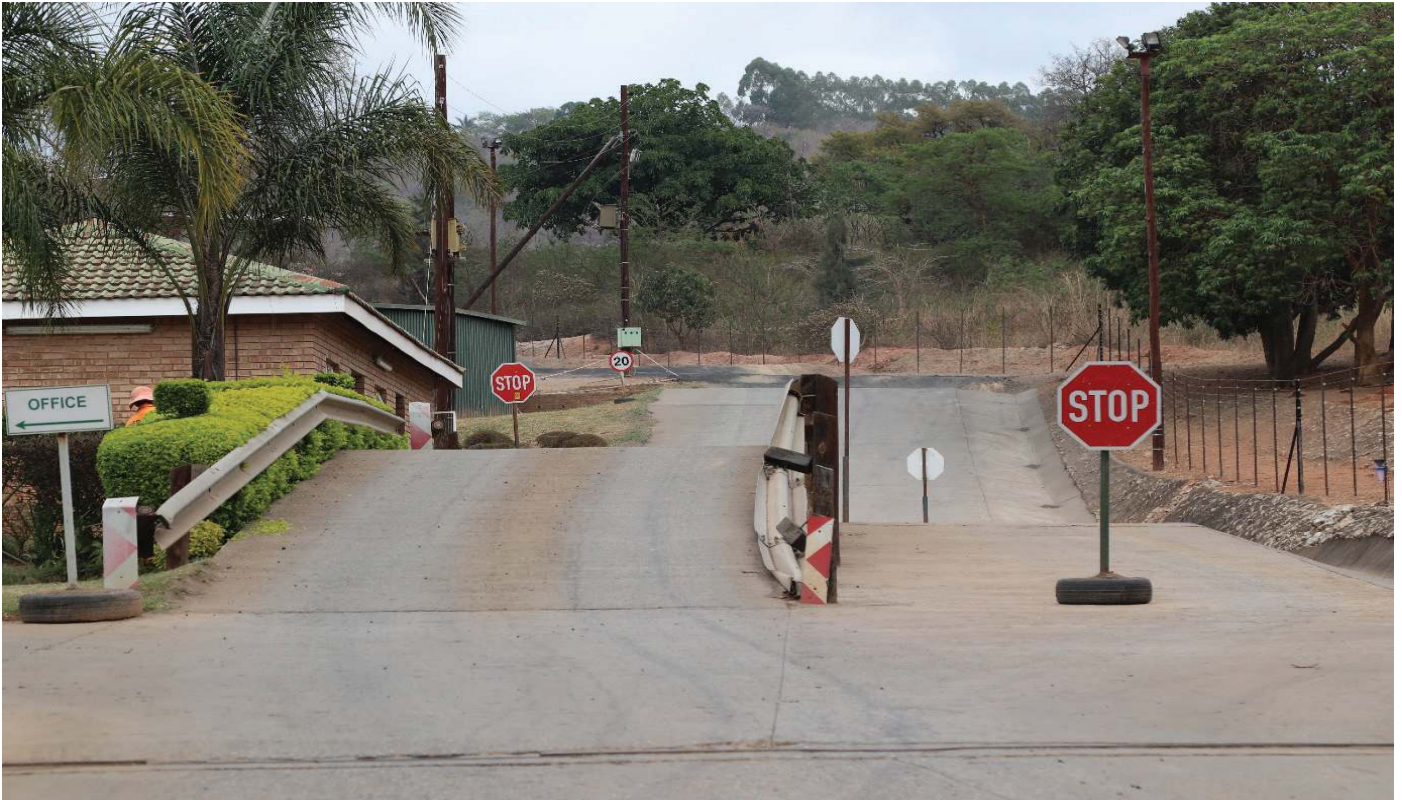
An impeccable landfill site in Tzaneen, with an operative weighbridge, fence and complete infrastructure

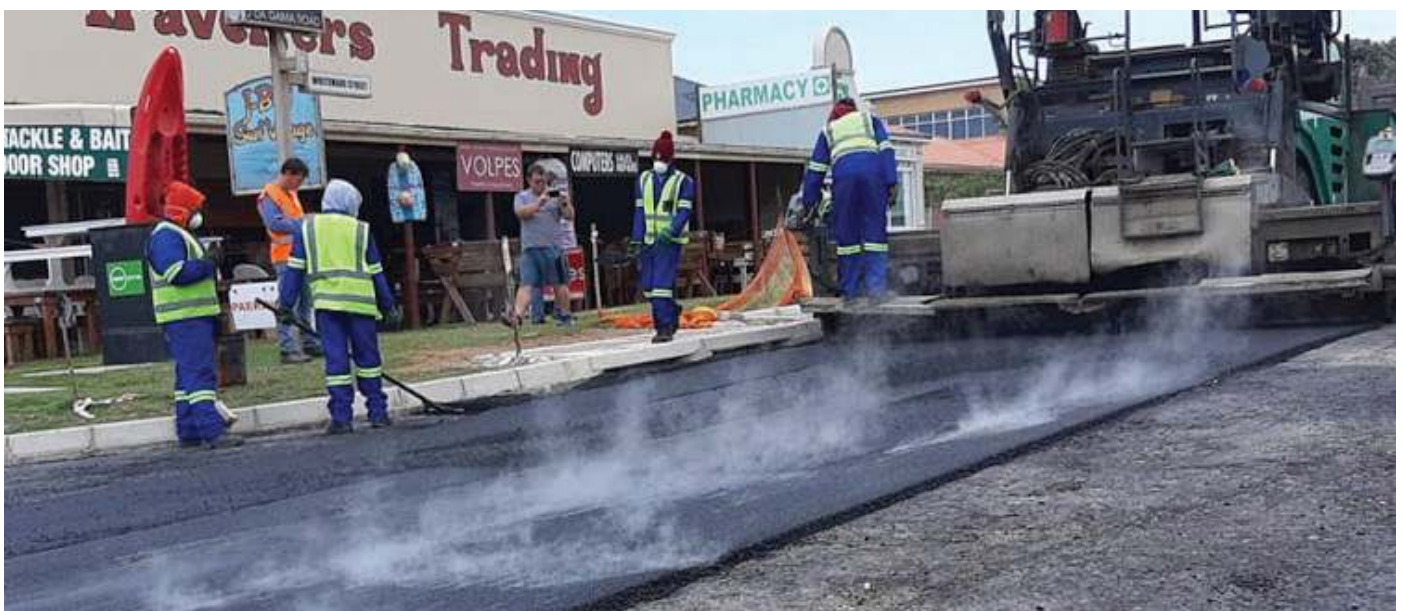
A street in Jeffreys Bay is repaired by making use of plastic waste
