MUNICIPAL LANDFILL AUDIT REPORT

2021

LAMBERT DE KLERK

Manager: Environmental Affairs

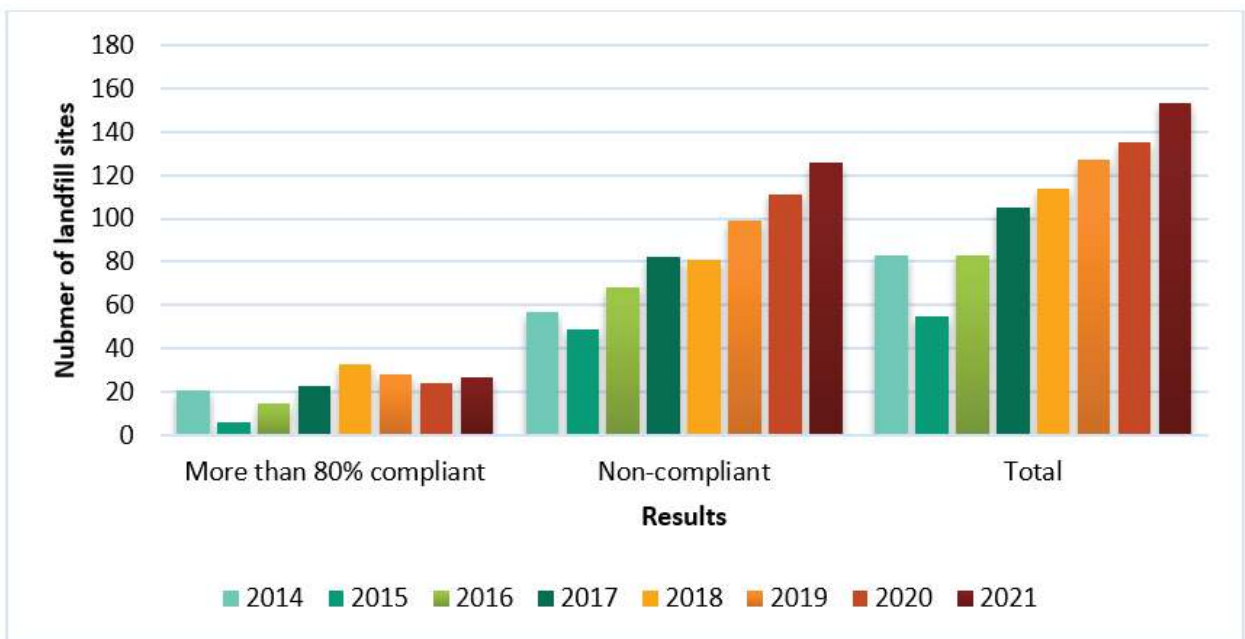
The audit results of 2014 to 2020 are compared in figure 4 below. It is not indicated in the graph whether the performance of landfill sites improved or deteriorated.

Figure 4: Comparison of the number of audited landfill sites complying/not complying for 2014–2021

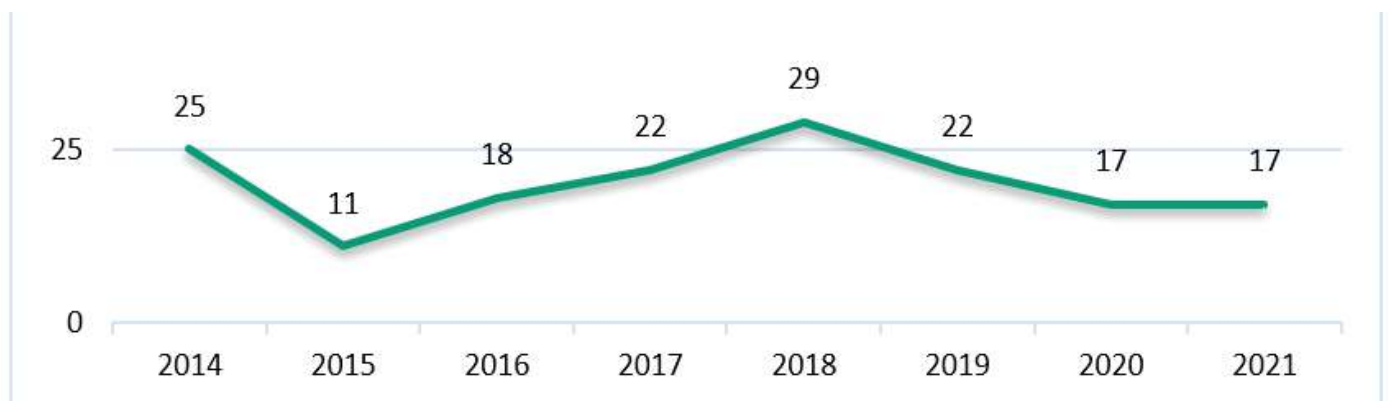
The percentage of compliance at national level for the period 2014–2021 is reflected in figure 6 below.

Figure 6: Average annual national compliance score (in percentages) for the period 2014–2020

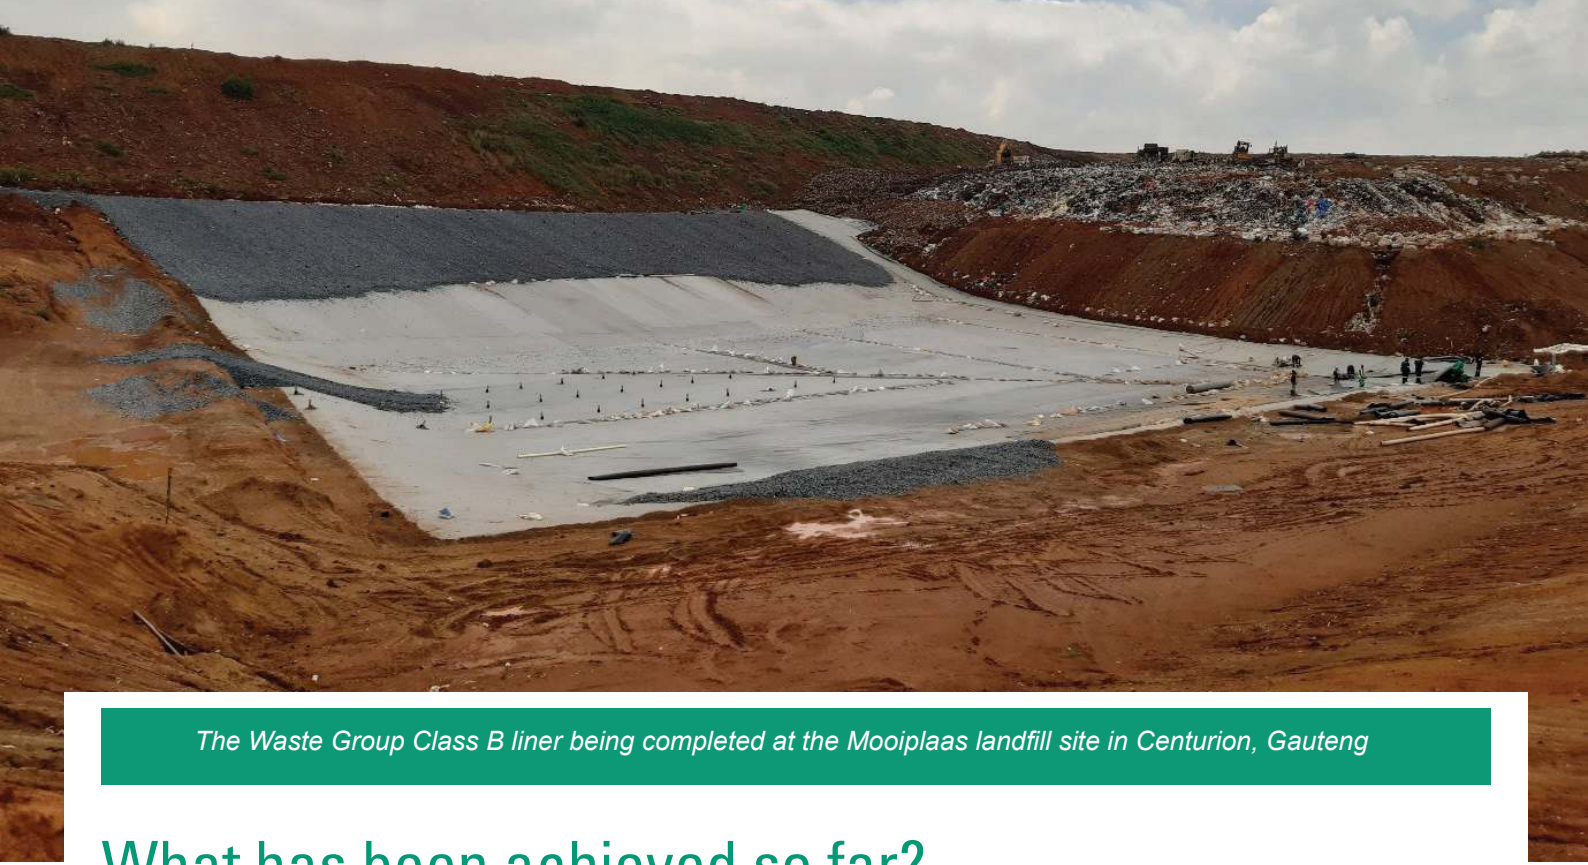
The Waste Group Class B liner being completed at the Mooiplaas landfill site in Centurion, Gauteng

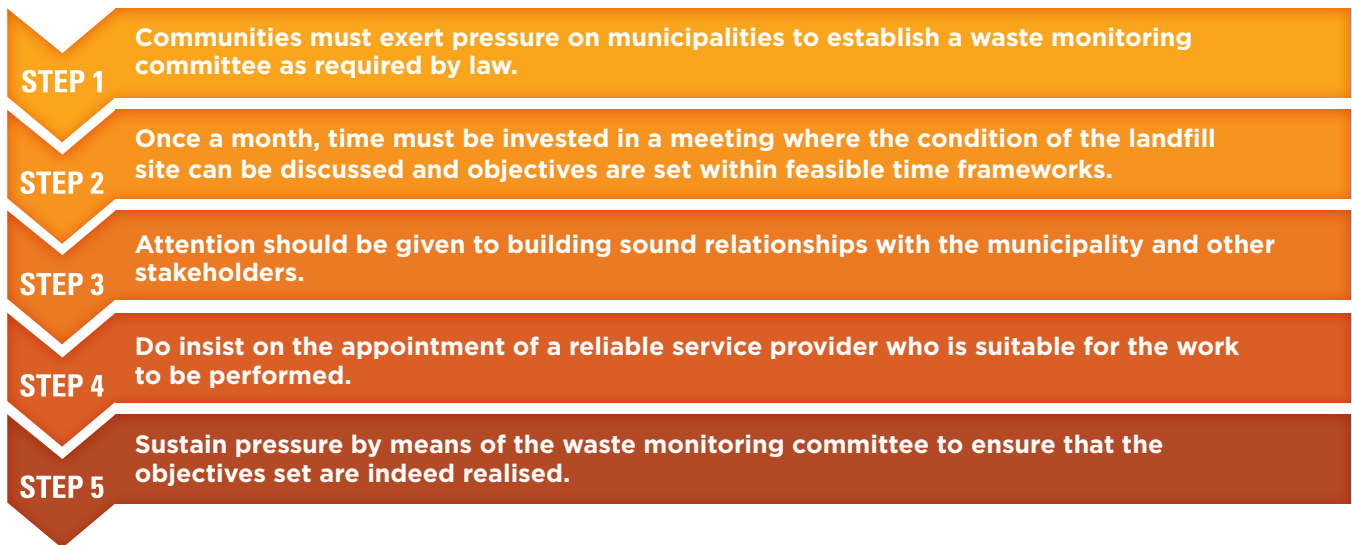
This process can be implemented by following the following steps as set out in figure 6 below.

Figure 6: Possible steps to be followed by communities to bring about sustainable improvement at a landfill site
